## **ERGONOMICS STRESSORS RESOLVED FOR MAINTENANCE OF EA-6B PROWLER TACTICAL JAMMING SYSTEM**

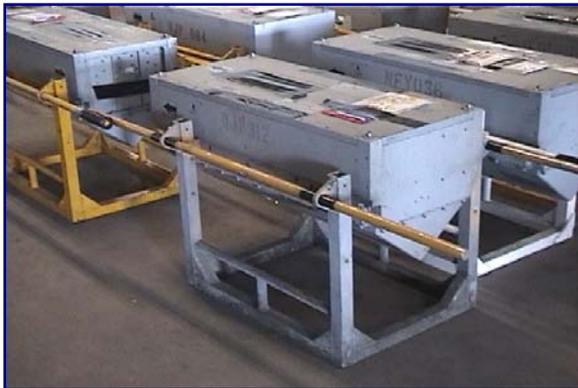
350+ lb asset transportation fixtures were manually moved within various facilities.

During transportation from the pod facility (where the assets are removed from the pods) to the repair area, technicians previously moved the assets with transportation fixtures that were manually lifted by two people (see picture at left). The assets weigh between 275-350 pounds with most of the weight being distributed at one end.

Transportation fixtures used to move assets were retro-fitted with wheeled dollies and provided to the two main asset handling shops at FRC NW. The dolly is placed under the carrying fixture so that the fixture can be wheeled to the maintenance area rather than carried. The dollies mitigated the hazards associated with manually carrying the transportation fixtures containing assets.

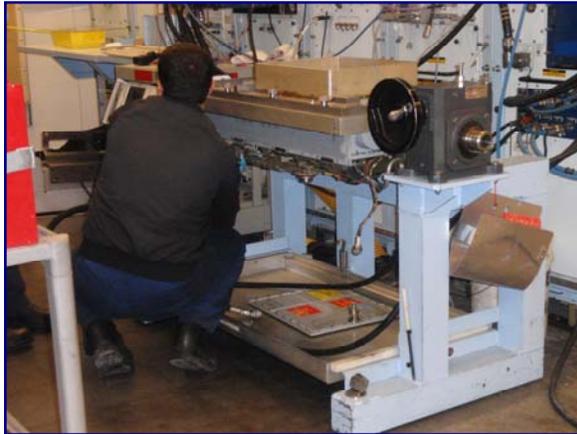
Technicians are required to work on all sides of the countermeasure equipment. They had to maneuver their bodies to reach all areas, often assuming awkward positions for extended periods (see picture below). The asset repair work required sustained awkward postures of the back, neck, and shoulders as well as the potential for high spinal forces associated with lifting and carrying the transportation fixtures and pushing the HRUs.

Original HRU was difficult to push and forced technicians to work in awkward postures due to its rear support structure and lack of height adjustability.

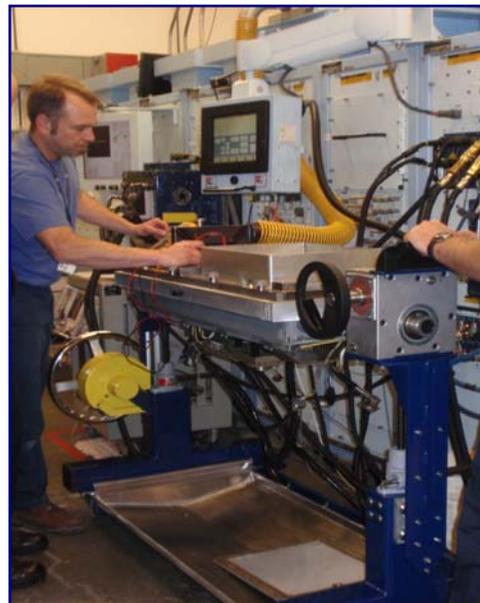
eHRU eliminates ergonomics injury risks

on the prototype design and end user testing to develop an ergonomic HRU, or eHRU, that eliminates ergonomics stressors during shore repair and maintenance operations on the EA-6B Prowler. Since the eHRU is only intended for shore operations, the eHRU design incorporated a wheeled design. Access to the equipment to be maintained/repared was greatly improved on the eHRU through alternative bracing, providing full access of the asset from both sides of the eHRU. Other ergonomics improvements incorporated in the eHRU include: pushing handles, clips to hold the Radiation Hazard Monitor probe, height adjustability, a drip tray that slides out, and a

cradle that attaches to the interface device holding fixture for power supply repair. These improvements reduced the amount of pushing, pulling, repeated bending, exertion of forces on wrists and the spine, and the need to assume awkward postures for long periods while working.

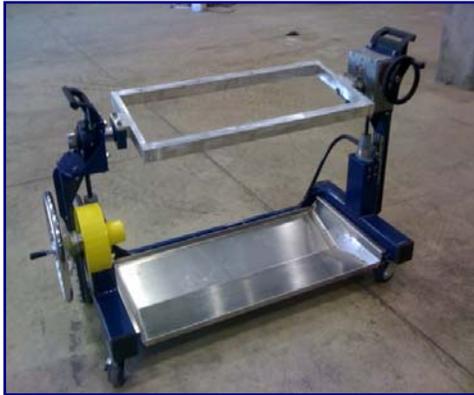
eHRU incorporates wheeled design improving maneuverability and access to assets

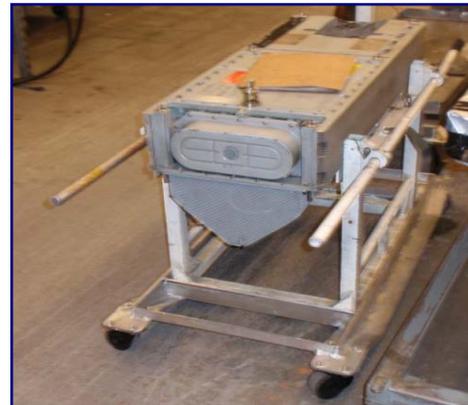
Transportation fixture retro-fitted with a wheeled dolly eliminates carrying heavy assets.
