The Navy & Marine Corps Aviation Maintenance Safety Magazine

# Mech

Summer 2014

The Navy & Marine Corps  
Aviation Maintenance Safety Magazine  
Summer 2014, Volume 52 No. 1

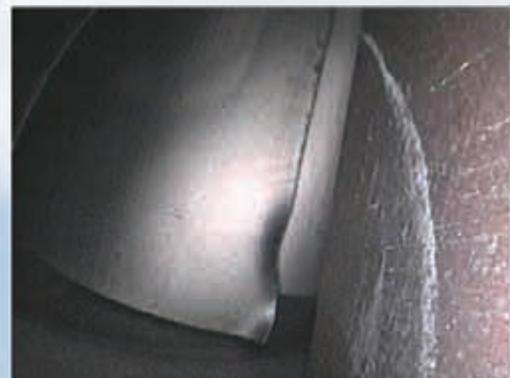
Damaged Compressor Blade

Just hours later, a deployed Clearwater maintenance crew from Great Inagua arrived on-scene, coordinated a security watch due to the desolate area, and completed a thorough borescope inspection of the engine. After the assessment, it was reported that the No.2 engine had ingested FOD and would require replacement.

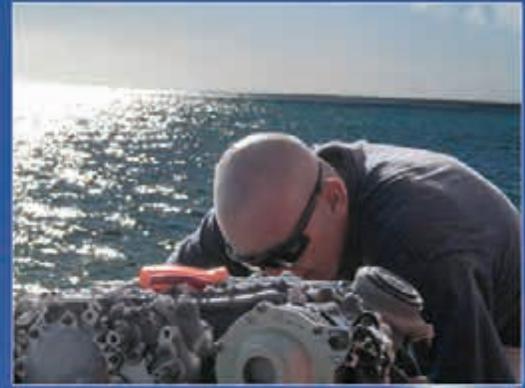
AMT1 Gary Spurgeon replaces an MH-60T engine

With a level platform and all equipment in reach, maintenance personnel removed the damaged engine and began installing the new engine. As daylight drew to a close, the site was cleaned up, tools were inventoried, and the maintenance crew was transported back to Matthew Town for the night.
