The Navy & Marine Corps Aviation Maintenance Safety Magazine

# Mech

Spring 2012

**The Navy & Marine Corps  
Aviation Maintenance Safety Magazine**  
Spring 2012, Volume 51 No. 1

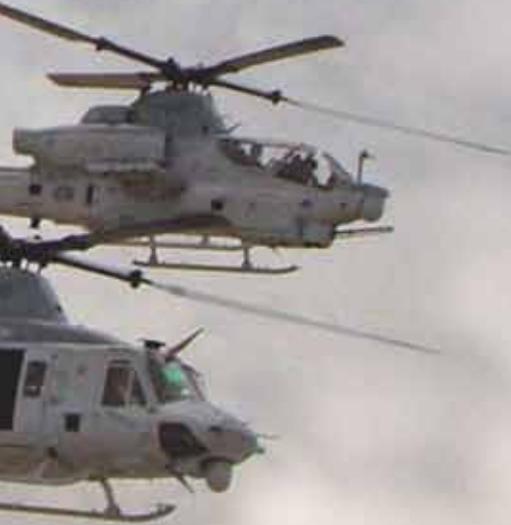
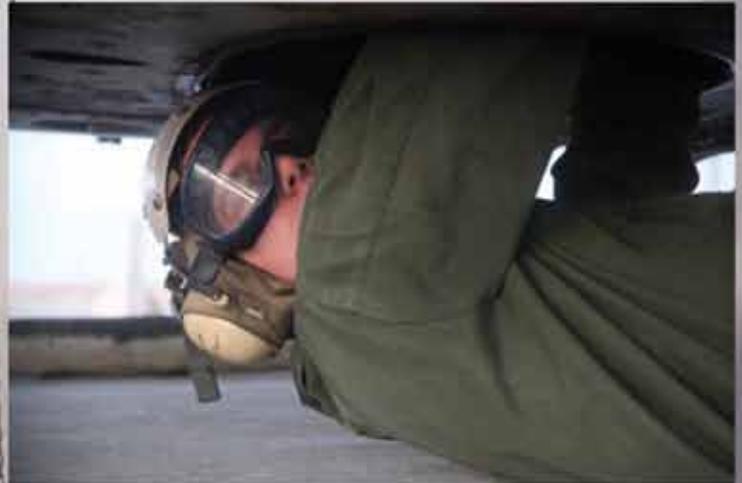
Sgt. Christopher Lemke, a mechanic with Marine Light Attack Helicopter Squadron 369, looks into the hell hole underneath a UH-1Y Huey helicopter at Camp Bastion, Afghanistan. Lemke discovered a previously unknown issue inside the tight space that represented an extreme risk to the aircraft and aircrew.

Underneath the UH-1Y Huey, in the aircraft’s transmission compartment (an area so difficult to reach that maintainers call it the “hell hole”), Lemke found something wrong.

“When two metals rub together, it creates this black liquid, and that’s what I found,” Lemke said. The transmission pylon beam and the main beam joint, which secure the aircraft’s transmission to the airframe, were disintegrating—an extreme risk to the aircraft and aircrew.

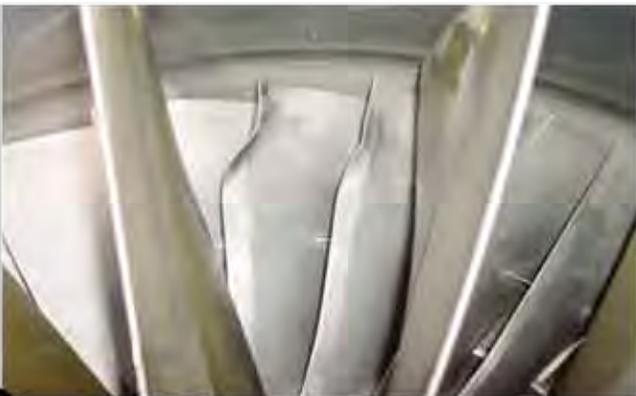
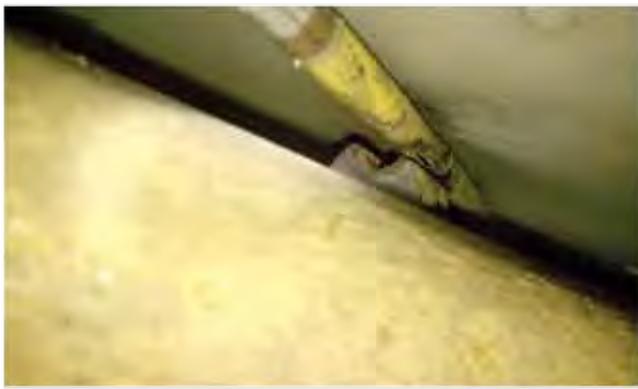
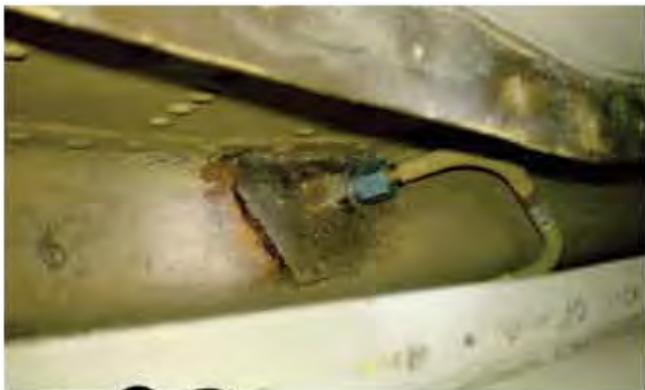
When aircraft 412 returned from an evening mission, the aircraft was chocked and shut down. The pilot climbed down the ladder. He debriefed the PC and troubleshooters with two thumbs up, stating that the jet was “good to go.” The young PC anticipated a quick turnaround and a possible early secure for night. However, as she entered the port intake to do the post-flight intake and fan inspection, she found significant damage to six blades on the first stage of the engine. A borescope inspection showed no damage to any of the internal fan stages.

An extremely thorough inspection and troubleshooting process ensued to address how the damage occurred. When the blades are curved forward toward the front of the aircraft, the damage either is typically caused by a “pop” stall or ingested ice. Our initial thought was the former, which is a reverse pressure differential that allows air to come back out the front of the intake. This kind of stall usually accompanies a loud bang, hence the name.

After shutting down the engine, the AMEs pulled panels and found a broken line. That line routes water from the water extractor to the heat exchanger. They also discovered the housing connecting the nozzle to the heat exchanger had torn away from the structure, causing excessive movement of the line, which in turn had chafed it to the point of failure.

The failure of the line caused water to leak from a panel and run over the bottom of the port intake. During engine operation, water flowed into the intake, froze at high altitude, and eventually broke apart and was ingested into the engine. Maintainers hadn’t paid too much attention to the water leak because some leakage is considered normal.

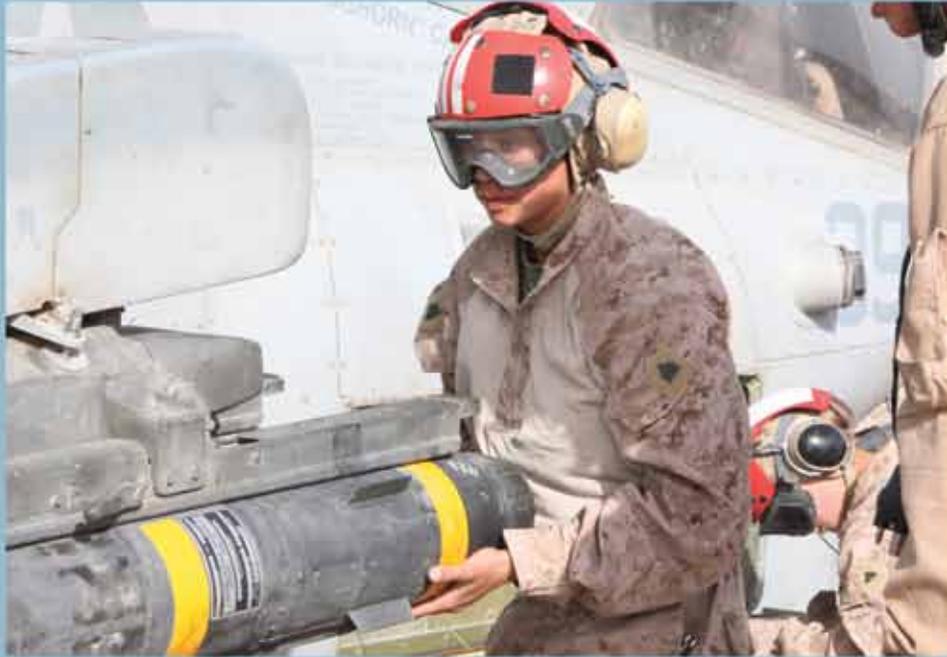
Sgt. Veronica Ortega, an aviation ordnance technician for HMLA-169 loads an AGM-114 onto AH-1W Cobra at a forward arming refueling point in Afghanistan's Helmand province. We were reloading an aircraft that was going back out into the fight, said Ortega. The forward arming refueling point was constructed to enable 2nd Marine Aircraft Wing (Fwd) to better support Marines and other coalition troops. Photo by Cpl. Samantha Arrington 2nd MAW (Fwd).

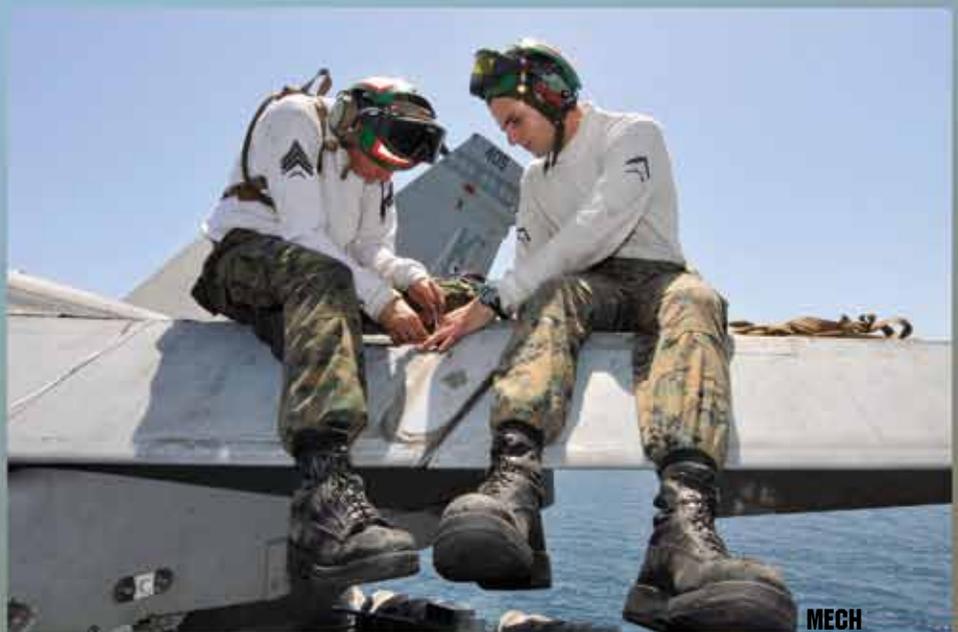
Sgt. Orlando Ortiz, and LCpl Michael Scott, both assigned to the VMFA-323, replace a wing fold proxy switch on an F/A-18 aboard the USS *Ronald Reagan* (CVN 76). Photo by MC3 Shawn Stewart.

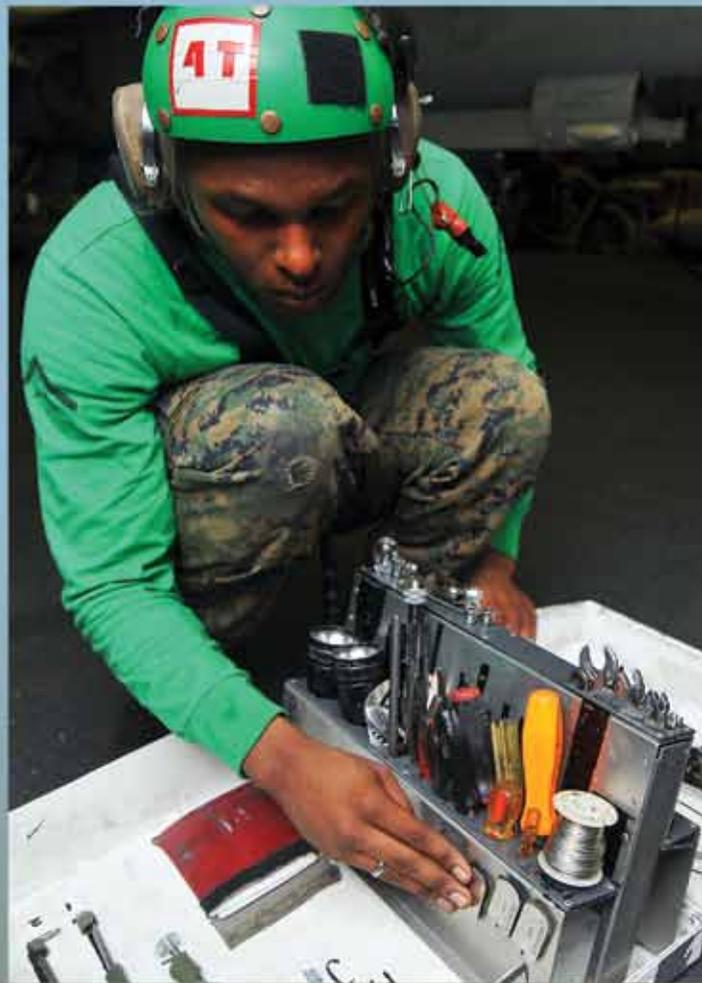
LCpl Randal Gibson, assigned to VMFA-323, performs a full toolbox inspection in the hangar bay of the USS *Ronald Reagan* (CVN 76). Tools should be inspected before you take on a job, checked while you are on the job and inspected after the job is done. Photo by MC3 Shawn Stewart.

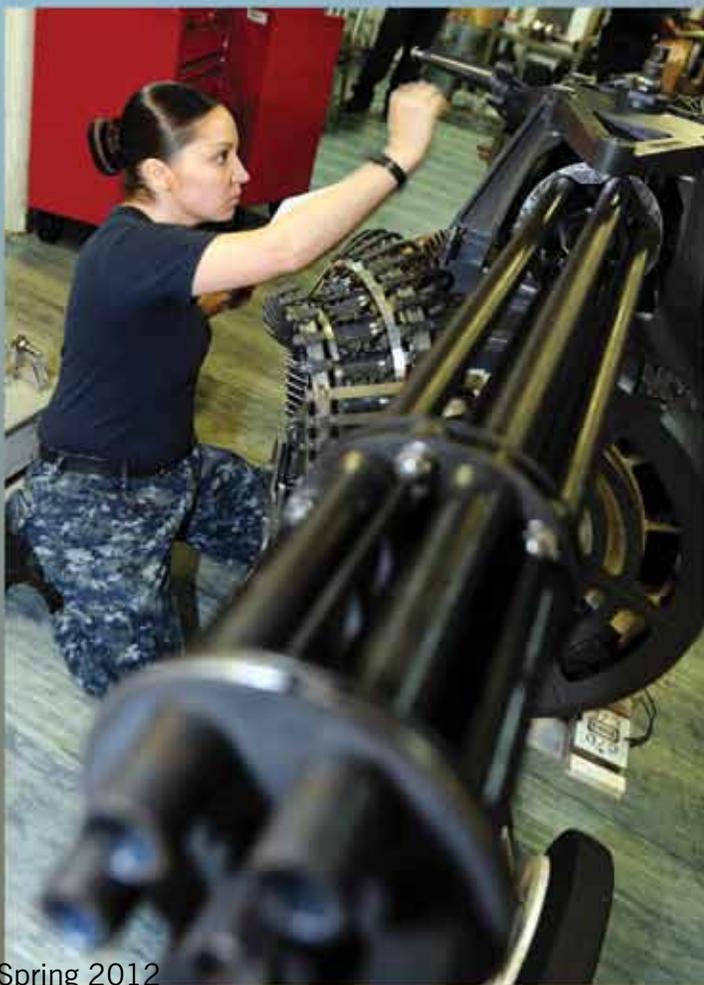
AOAN Laticia Workman performs an inspection on an M61A-2 Vulcan 20 mm Gatling gun aboard USS *George H.W. Bush* (CVN 77). Photo by MC3 Billy Ho.
