# Mech

Winter 2013-14

**The Navy & Marine Corps  
Aviation Maintenance Safety Magazine**  
Winter 2013-14, Volume 51 No. 4

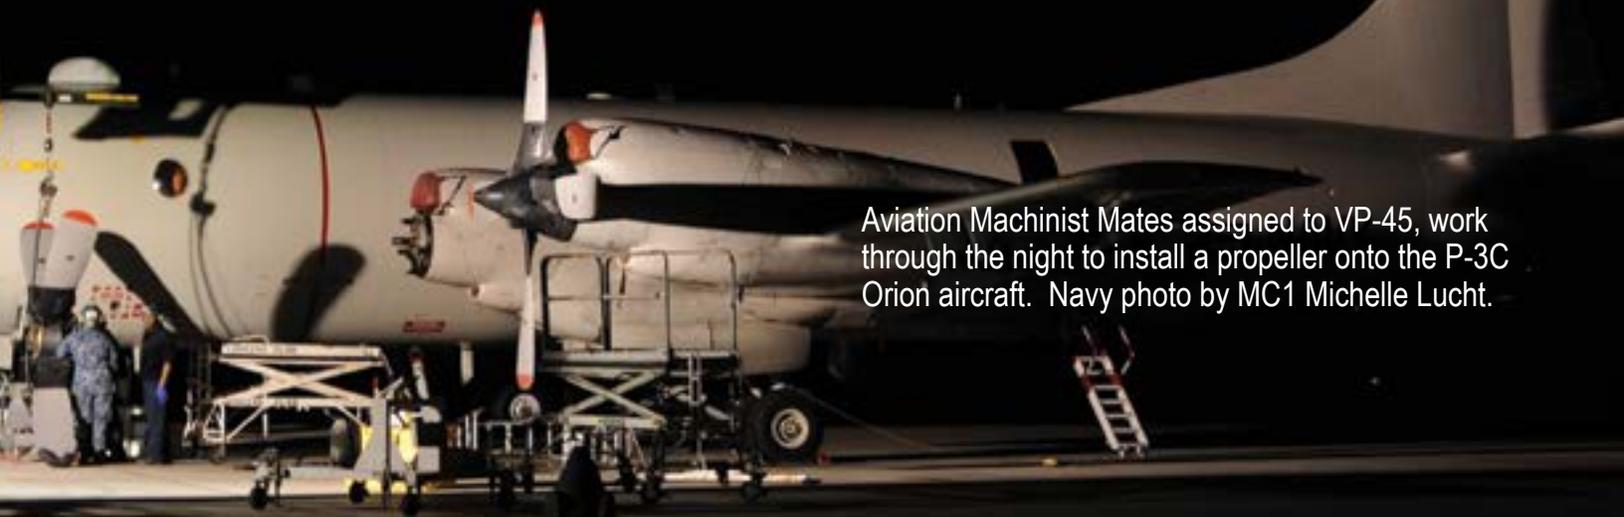
Aviation Machinist Mates assigned to VP-45, work through the night to install a propeller onto the P-3C Orion aircraft. Navy photo by MC1 Michelle Lucht.

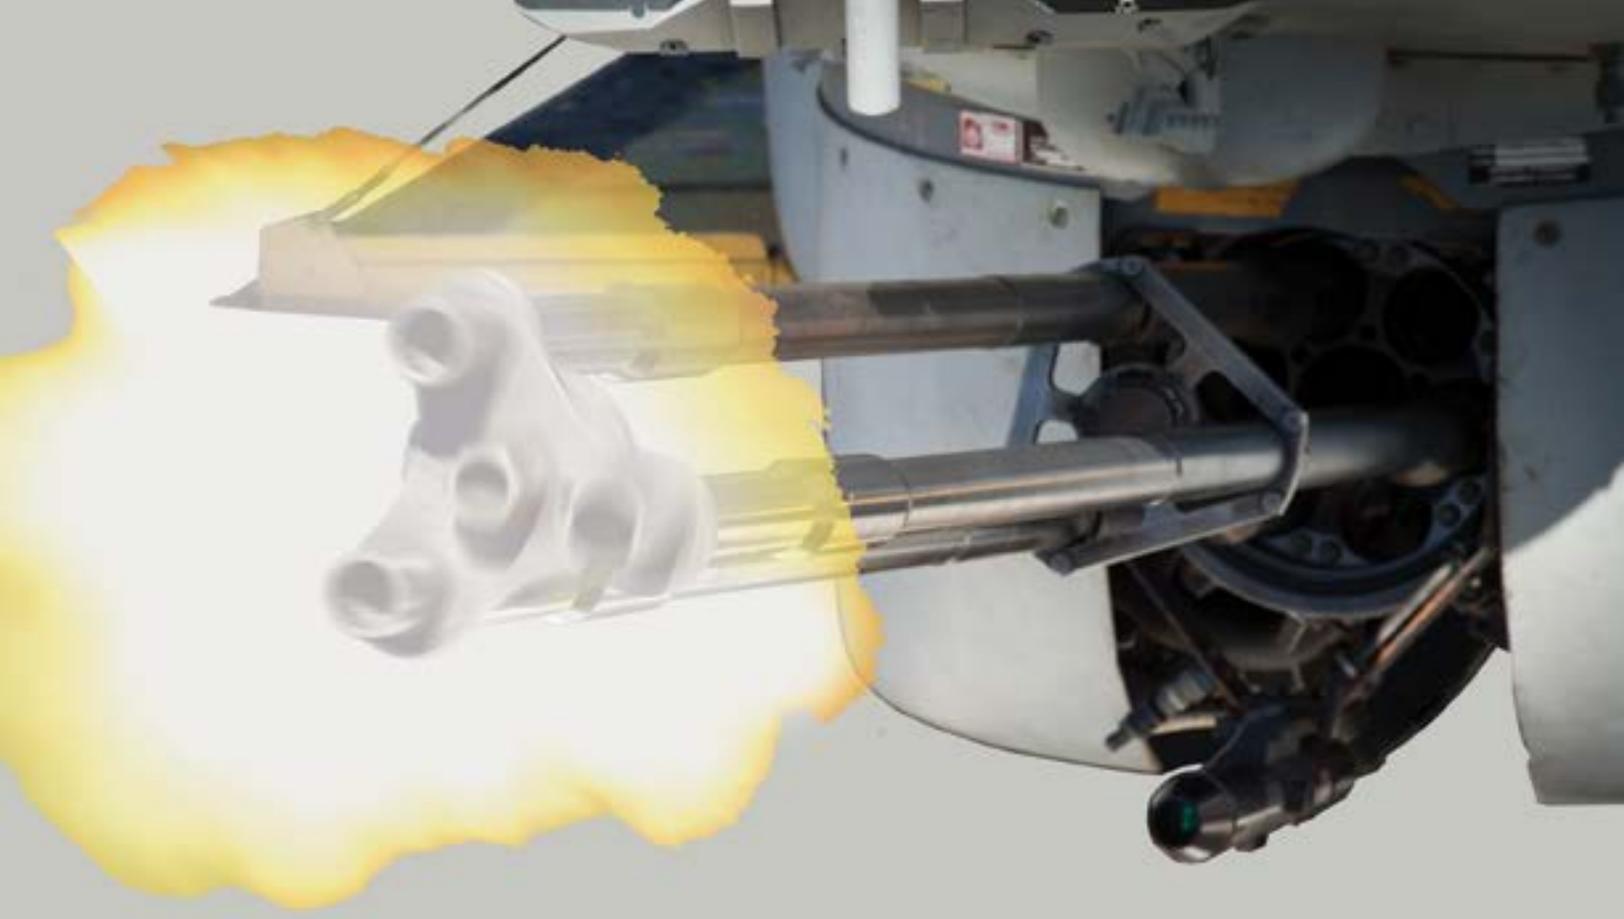
**After clearing the area immediately forward of the aircraft and incorrectly visually inspecting the feed-chute, feeder, and gun for any remaining rounds, the ordnance maintenance team QASO started to duplicate the discrepancy.**

The QASO cleared the area immediately forward of the aircraft but didn't use the established checklist to visually inspect the feed chute, feeder, and gun for any remaining rounds. He started to duplicate the discrepancy.

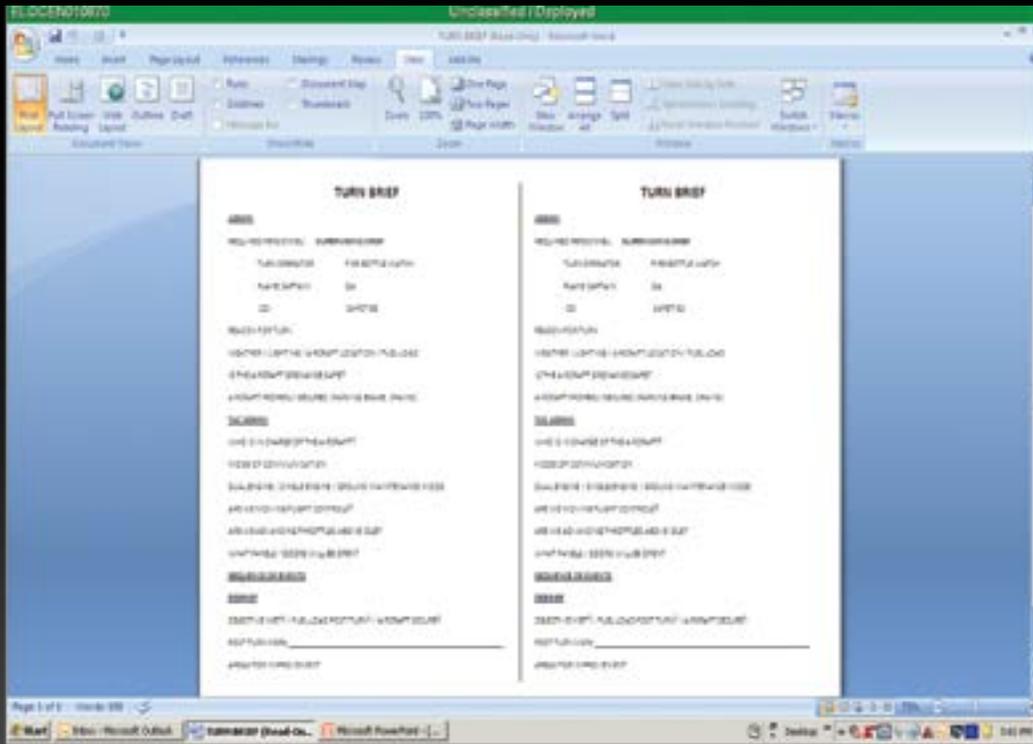
Added NATOPS requirements to the back of the Wing Turn Briefing Card.

Above is the new turn brief card that our aircraft division officer and maintenance officer implemented. It mimics what pilots use on every brief before and after each flight. We printed this information on the back of a standard Strike Fighter Wing instruction turn card. This card allows a framework for us to brief and debrief each turn. It ensures that we discuss the whole evolution and identify possible hazards, so that all turn personnel are on the same page and don't have any questions.

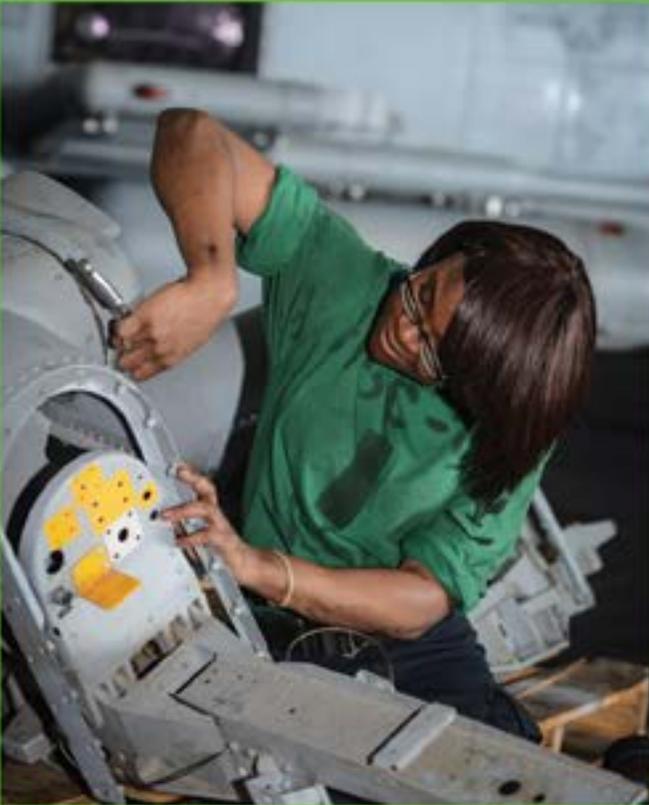
Aviation Structural Mechanic 3rd Class Lakesha Clark, assigned to the HSC-6, adjusts screws for an MH-60S Sea Hawk helicopter aboard the aircraft carrier USS *Nimitz* (CVN 68). Navy photo by MCS Derek Harkins.

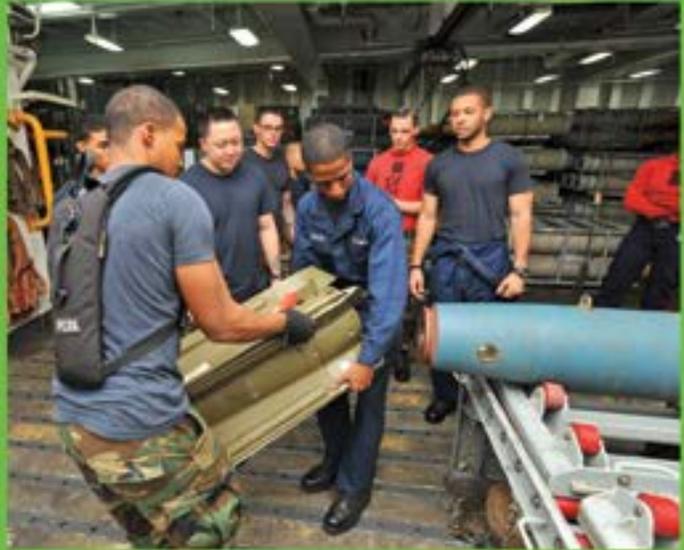
Aviation ordnancemen assemble a GBU-12 inert training round aboard the amphibious assault ship USS *Boxer* (LHD 4). Navy photo by MC3 J. Michael Schwartz.

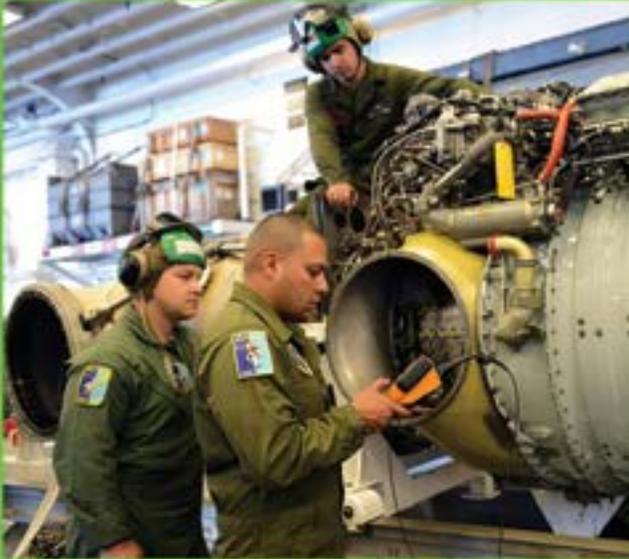
GySgt Leonel Lora, middle, assigned to the 31st MEU, uses a bore scope camera to verify the engine of an AV/8B is serviceable while SSgt Steven Vladiff, left, observes and Cpl Justin Powers, top, turns the blades of the engine in the hangar bay aboard the USS *Bonhomme Richard* (LHD 6). Navy photo by MC2 Betsy Knapper.

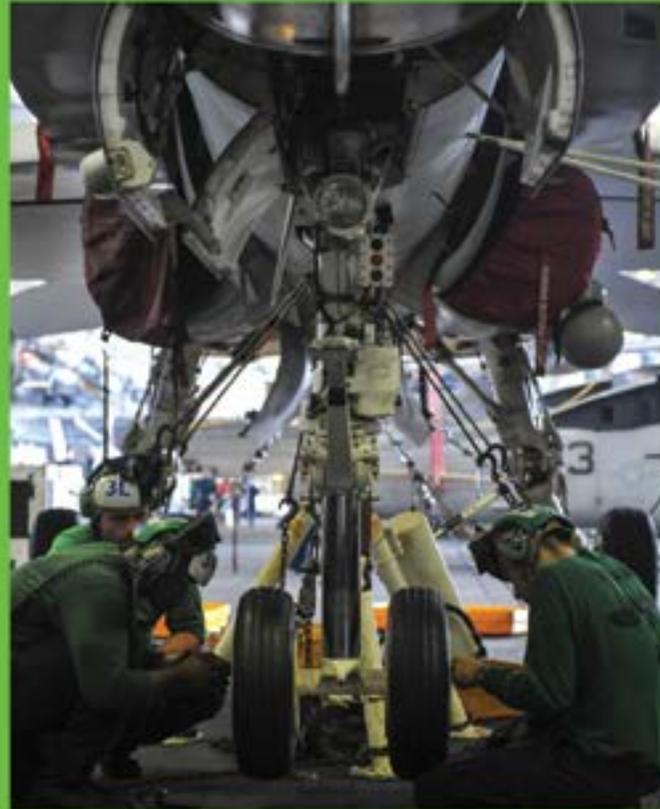
Aviation Structural Mechanic (Equipment) 2nd Class Christopher Miller, rear left, Aviation Structural Mechanic 3rd Class Phillip Welch, front left, and Aviation Structural Mechanic (Equipment) 2nd Class John Dobson install new tires on an F/A-18C Hornet assigned to VFA-146 in the hangar bay aboard the USS *Nimitz* (CVN 68). Navy photo by MCS Eric Butler.
